**Compliance Testing Report for
Australian/New Zealand Standards
AS/NZS5110:2010 (Draft)
Recessed Luminaire Barriers
(Partial Testing Only)**

Client:	Efficiency Matrix
Address:	14 Ondine Drive, Wheelers Hill, Victoria 3150
Report Number:	1018EFFDOWMIT01_5110P Replacement for report 1013EFFDOWMIT01_5110P
Date of Testing:	18 th of October 2010
File Number:	EFF100930
Equipment Name:	Loft Mitt
Equipment Model Number:	Dowmit01
Equipment Description:	Testing Loft Mitt to Draft Standard AS/NZS5110:2010
Result:	Refer to summary page
Tested by:	James Emery Electrical Safety Test Engineer

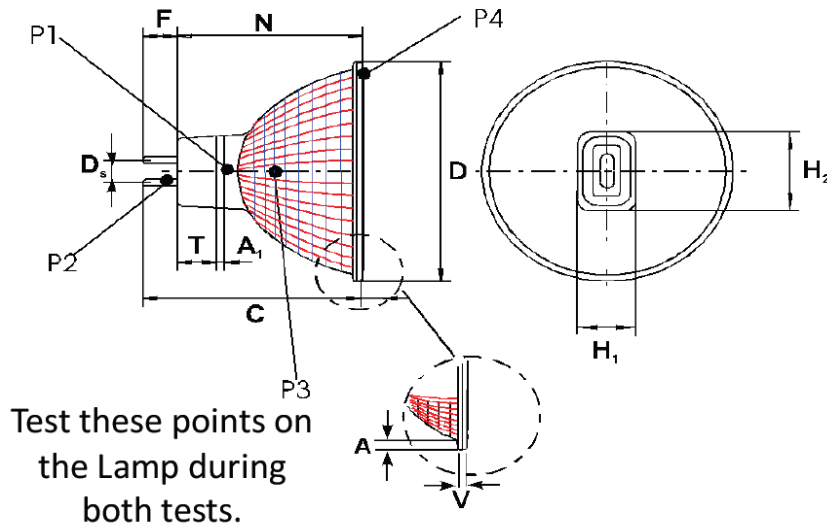
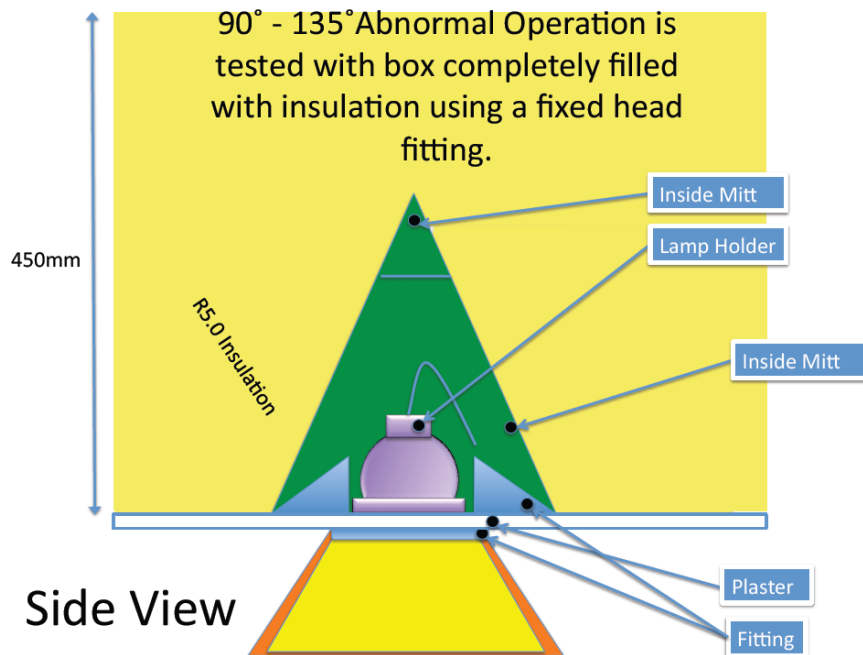
50W Dichroic Lamp Temp Points

5.7	TABLE: temperature rise measurements for abnormal operation Test Box completely filled with R5 rated insulation. Test was conducted for 8Hrs. Values shown are maximum temperatures achieved. Temperatures are adjusted to an ambient temperature of 25 degrees Celsius.		P
	test voltage (V)	264 V	—
Temperature (°C) of part		Max. Reached T (°C)	Max. Allowed T (°C)
P1		338.8	Refer to Manufacturer Data
P2		266.4	Refer to Manufacturer Data
P3		226.0	Refer to Manufacturer Data
P4		198.0	Refer to Manufacturer Data
Lamp Holder		240.4	Refer to Manufacturer Data
Lamp Fitting		96.4	135
Plaster		50.6	135
Ballast power cable at lamp holder		169.0	200
Ballast power cable 40cm from lamp holder		128.6	200
Mitt inside Lower		106.5	Refer to Manufacturer Data
Mitt Inside at top		111.4	Refer to Manufacturer Data
Exterior of ballast		83.3	90
Outside Mitt left side		75.7	135
Outside Mitt right side		81.3	135
Outside Mitt at top		87.2	135

Top of Enclosure		31.8	135
Ambient		23.0 (Adj. to 25)	20-30
